Back Pressure Opens Safety Valve on Idle Boiler

Several Recent Explosions of Heating Equipment

Hot Water Heating System Boilers Explode

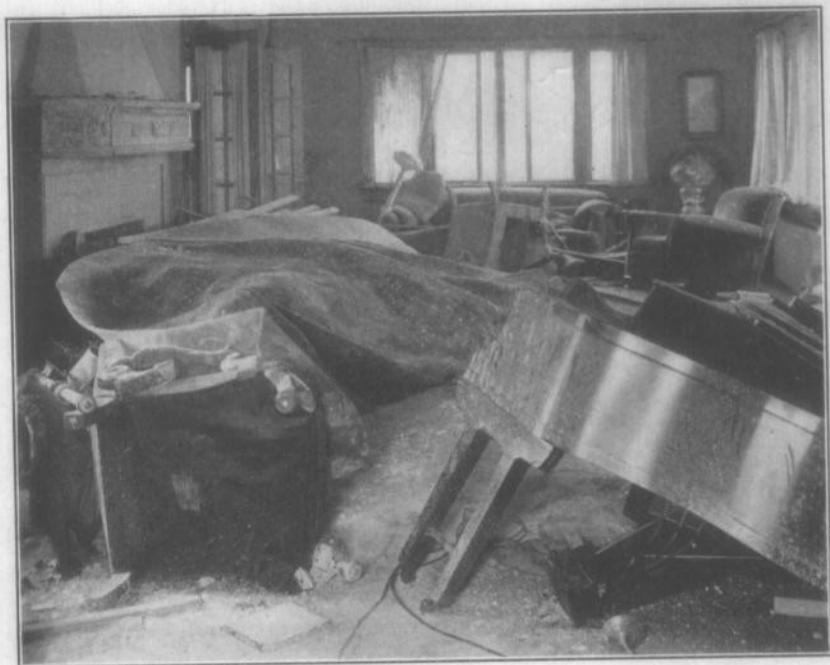
TWENTY-FOUR guests at a Halloween party in Sidney, Ohio, had narrow escapes from injury when a cast iron heating boiler exploded a few minutes after they had left the home of their hosts, causing damage to the house and furnishings estimated at \$22,000. The boiler stood directly beneath the living room in which the guests had been seated. Figure 1 shows the room as it appeared after the

blast. A nursemaid and a baby who were asleep on the second floor were not injured, although ensuing fire threatened to block their escape from the building.

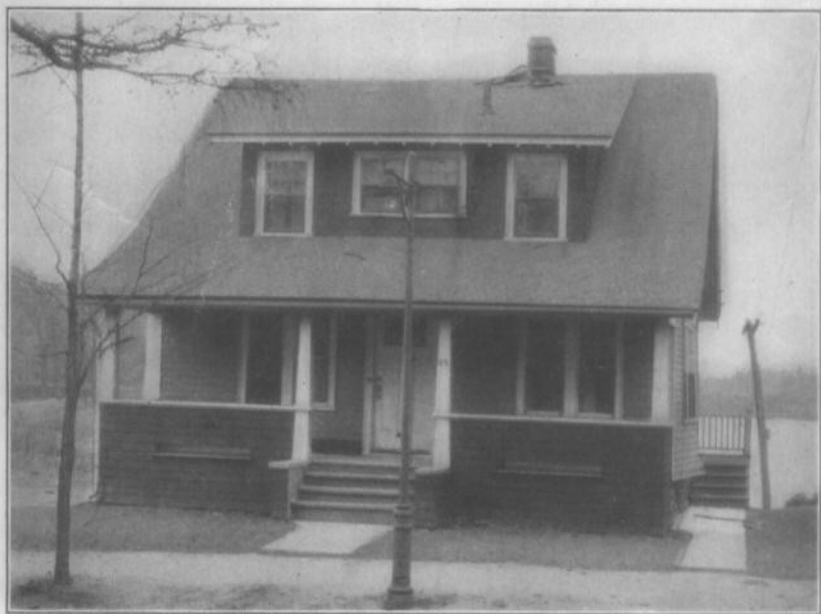
Another recent explosion occurred on New Year's Day at a residence in Worcester, Mass., where a hot water supply tank shot up through two floors to the roof. Figure 2 shows the hole in the roof where the tank struck, as well as a bulged side wall, but it does not give an adequate idea of the damage to the framework and interior. As in the case previously described, the lower floor of the house was wrecked. Furniture was tumbled about, plaster was shaken down, gas pipes and electric light fixtures were broken, and radiators were wrenched from their fastenings. Because heavy floor beams were broken and the whole framework was seriously impaired, the owner was of the opinion that the house would have to be virtually rebuilt.

The tenants were not at home when the accident occurred. It appeared that some one had accidentally left the gas coil heater burning.

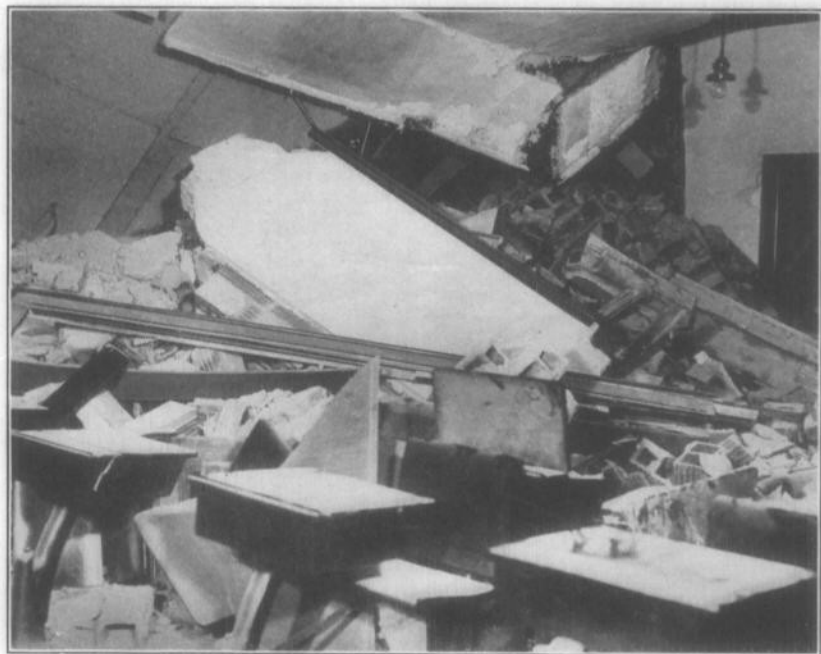
Figure 3 is a view of a room of the McKinley school in Willobee, Ohio, where the explosion of a hot water tank during the Christmas recess caused property damage estimated at \$15,000. Only one man, an electrician, was in the building at the time. He was fortunate in escaping injury as he was working in a narrow space between the roof and the ceiling of the room here shown. He was obliged to dig his way out after the explosion hurled debris over the trap-door exit. Had the explosion occurred a few hours later many lives would have been endangered, for that evening the school team was to have played a basketball game in the building.

The tank was of lap-welded construction, about 30 inches in diameter and four feet in length. It was protected by a safety valve supposedly set to relieve at a pressure of 60 pounds per square inch. Failure occurred by the blowing out of the minus head which tore through the base of a 90-foot brick smokestack and brought it down. The tank itself was driven endwise through a wall, the shock being sufficient to collapse the roof and damage one class room, the assembly hall, and the cafeteria.

When examined after the accident, the safety valve was found to have had its spring screwed down so far that the coils were nearly squeezed together. Under test, the valve dripped slightly at a pressure of 135 pounds and opened as wide as the compressed spring would permit at 145 pounds.

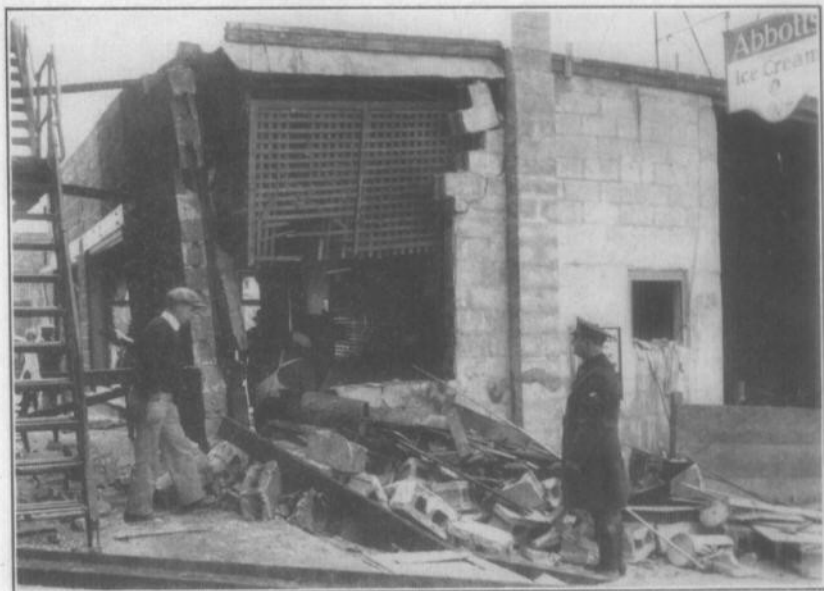
The proprietor of a candy shop in Audubon, N. J., was serving a customer a cup of hot chocolate on the afternoon of March 9 when the hot water system heating boiler exploded and hurled both men through a window into the street. Fortunately, the plate glass preceded them by a fraction of a second, so they escaped with minor bruises and cuts. Figure 1 shows the rear of the store. The back wall of concrete blocks was hurled down, and the side wall was tilted outward so as to be in danger of collapse. A newspaper account stated that the property damage amounted to about \$5,000.

Reports indicate that the system was installed without either an expansion tank or a relief valve. Coke was being used as fuel, and as the day was cold and windy it was suspected that the vigorous firing necessary to meet these conditions was too much for the boiler.

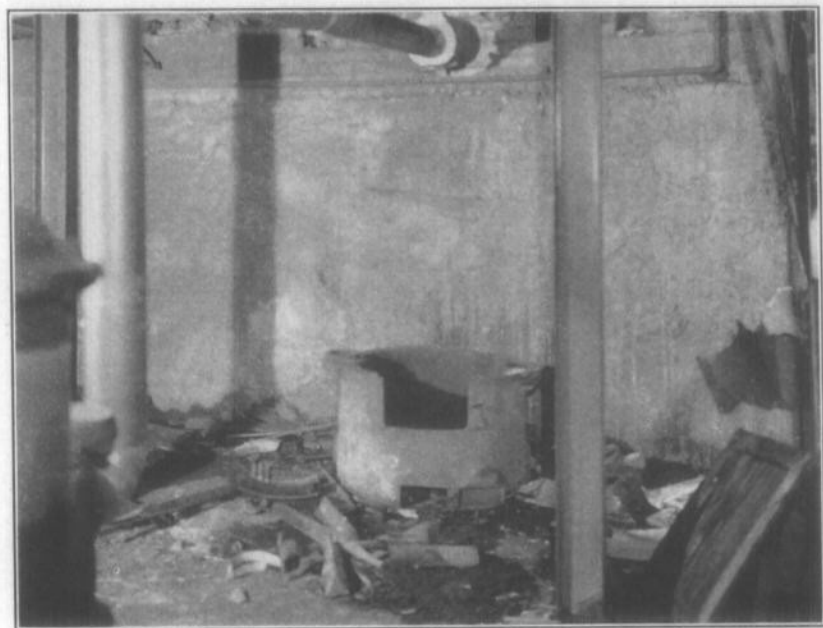
Figure 2 shows what was left of the firepot section of a hot water heating boiler that exploded on March 11 in the basement of a pumping plant in Haverhill, Mass. This, too, was a closed system, but one having an air-tight expansion tank and a differential relief valve. The top and third sections of the boiler crashed upward through the first floor, forcing a 12" x 6" beam out of its anchorage in the brickwork, and raising the whole first floor up about three inches. Other parts of the boiler caused considerable damage to the plant switchboard, bending

switch handles, breaking a slate panel, and piercing an iron grill protecting the oil switch. The steel-trussed roof of the building was also raised by the concussion. One of the trusses pulled the brick side-wall about four inches out of perpendicular at the resting place of the truss.

During the morning the attendant noticed that the return pipes and about one-third the height of the radiators were cold. He supposed that the system was air-bound, so he tried the pet cocks on the radiators and drew a small amount of water from the system before admitting sufficient makeup water to bring the gauge up to the normal pressure of about 8 pounds. He noted then that the thermometer on the boiler read 140°F. Twenty minutes after he had thrown on a little coal and

Neither the relief valve nor the expansion tank was damaged by the explosion. When tested, the valve worked freely at 25 pounds. The cause of the accident could not be positively determined. In view of the fact that boiler had been used previously at another location—and possibly under conditions that may have affected the strength of the castings—failure might have occurred under normal operating conditions. If the water had been brought to the boiling temperature corre-

sponding to eight pounds pressure there would have been sufficient energy stored in the boiler to account for the damage done by its failure. If such was the case the safety valve, set to blow at 25 pounds, would not have had any opportunity to act.

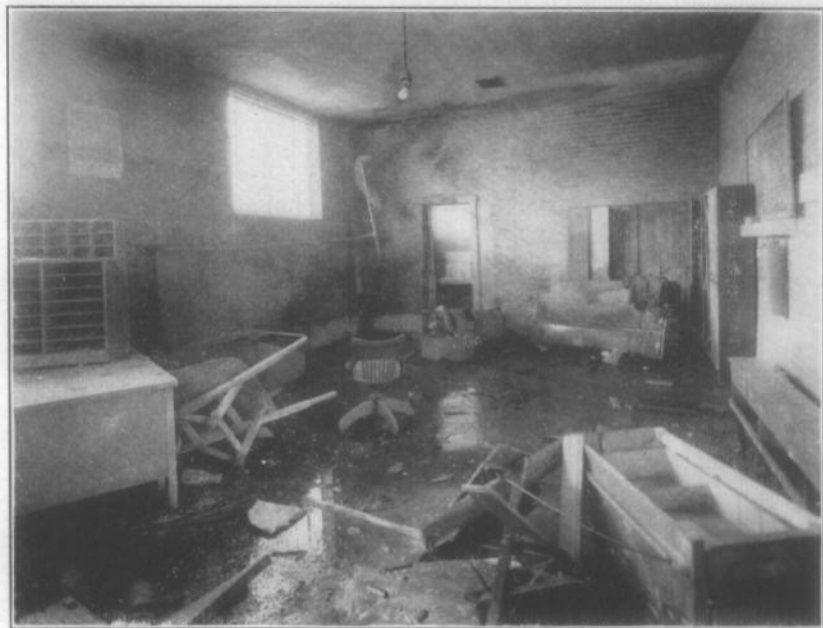
Figure 3

The last of several employes of a garage in Peoria, Illinois, had just left the locker room shown in Figure 3, on the morning of January 18, when a small cast iron boiler used for supplying hot water, exploded, smashed furniture, knocked out windows and doors, and raised the ceiling. The men had just changed to their work clothes, preparatory to beginning the day's work. Had the explosion occurred while

they were in the room it is probable that some at least would have been seriously injured. This heater was not equipped with any means for relieving overpressure, nor was there a device for temperature control.

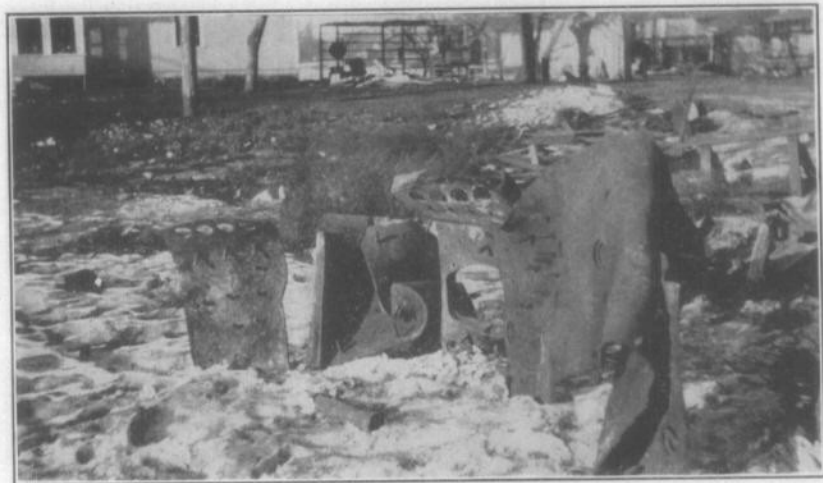
In Figure 4 is shown the wreckage of a welded steel hot water supply boiler that exploded January 28, in a building at Yakima, Washington. This boiler was connected to a welded hot water supply tank and neither boiler nor tank was equipped with a relief valve. The day

before the accident the water was shut off from the main in the street. The following morning the engineer fired up the boiler and the explosion occurred three-quarters of an hour later, causing property damage estimated at \$2,000.

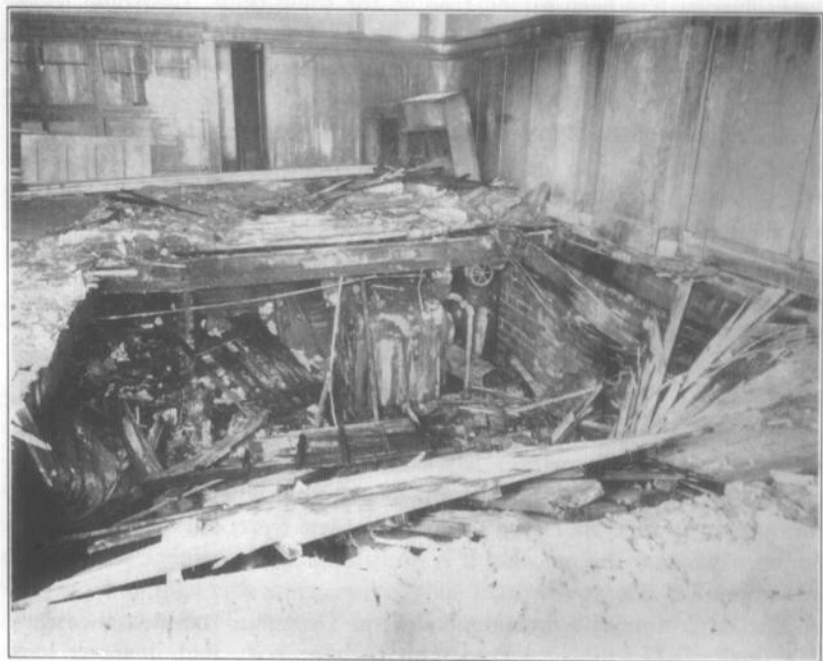
THE account we have received of the heating boiler explosion pictured below, indicates that the safety valve was either inoperative or else it was not large enough to relieve pressure that increased rapidly when an attendant closed the stop valves in both the steam and return lines. This accident occurred on December 2 at the

showroom of a large automobile agency, and although several automobiles on the showroom floor were badly damaged—two of them falling into the hole shown in the picture—only one person was injured. That happened to be a passerby who stopped to look at the display of cars and was cut by pieces blown from the plate glass window.

Two coal fired cast iron sectional boilers comprise the battery used for heating the showroom. During extremely cold weather both boilers are used at a pressure of from five to ten pounds, but at the time of the accident the weather was unusually mild and only one boiler was in use.

The boiler was hurled about twelve feet from its setting and driven through a stout brick fire wall. The damage was estimated at \$10,000.00. As far as is known, there was no boiler insurance in effect.

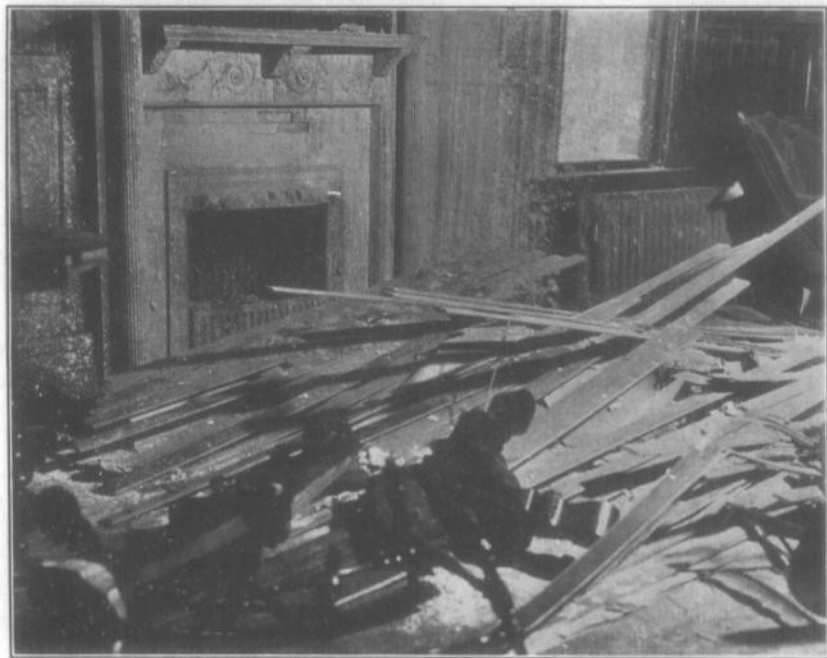
A furnace gas explosion in the basement of Governor William G. Conley's executive mansion at Charleston, West Virginia, nearly resulted in the death of West Virginia's first citizen. Becoming chilly on a Sunday night and knowing that servants were away he went personally to the basement to determine why the gas burner in the furnace was not functioning. Cautiously he opened the furnace door with a stick and an

explosion of terrific violence occurred almost immediately. Governor Conley was burned about the face, but he was able to shut off the gas and avert further trouble. The cause of the accident was attributed to ignition of the gas and air in the furnace by a pilot of a nearby hot water heater. Damage to the mansion was estimated at \$1,000.
